Manhole Inspection Summary

Manhole # S43C__035MH

Insp Date: **4/13/08 12:41 PM**

Location Address: **Fayette St**

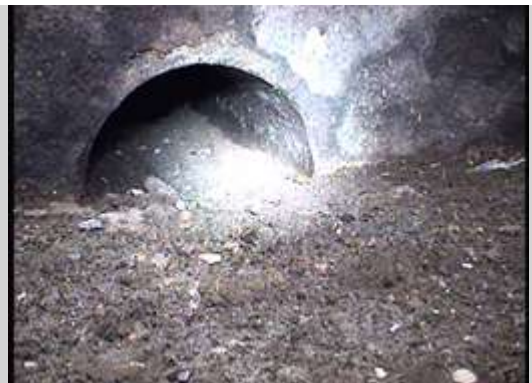
12 O'Clock Outflow

8 in. Circular Gravity Sewer
Pipe Out @ 12 O'Clock

Deposits: ☐ None ☐ Mud ☐ Sludge ☒ **Debris** ☐ Grease

Silt Depth: **4** (in.) Deposits Extent: **Light**
